# Manhole Inspection Summary

Manhole # S53A\_\_025MH

Insp Date: **3/16/09 11:52 AM**

**Location** Address: **rear 3210 pulaski hw**

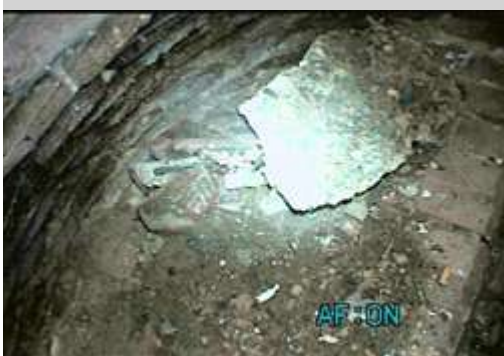
Misc.

bench debris

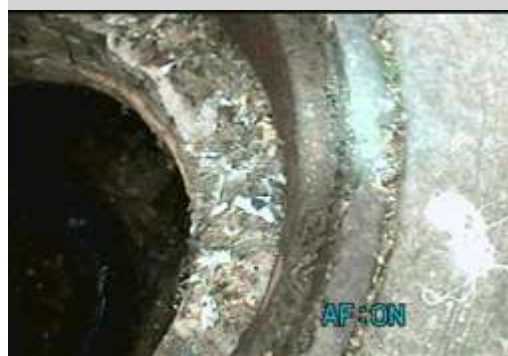
Defect 2

**Frame** Offset: **4** (in.) Condition: ☒ Sound ☐ Cracked ☐ Leaks

offset

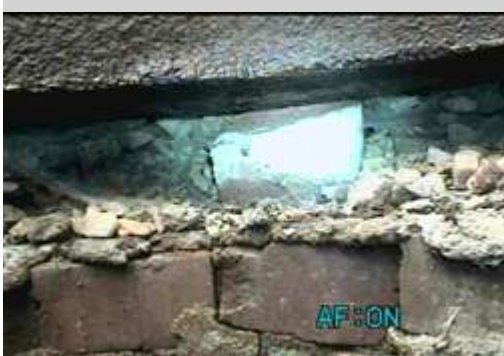
Defect 1

Condition: ☐ Sound ☒ **Cracked** ☐ Root Intrusion ☒ **Loose Brick** ☒ **Deteriorated**

frame adj cracked, loose bricks, deteriorated

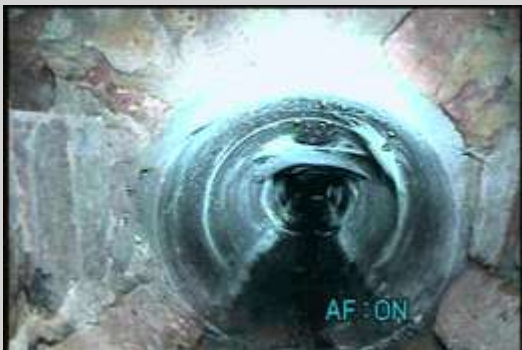
12 O'Clock Outflow

8 in. Circular Gravity Sewer  
Pipe Out @ 12 O'Clock

Pipe Material: **Clay** ☐ Pipe Lined

Invert Depth: **5.66** (ft.) Flow Characteristics: **None**

Infiltration: **None** Pipe Seal Cond: **Unknown**

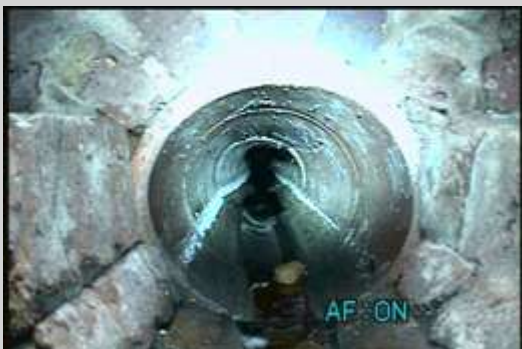
4 O'Clock Inflow

8 in. Circular Gravity Sewer  
Pipe In @ 4 O'Clock

Pipe Material: **Clay** ☐ Pipe Lined

Invert Depth: **5.62** (ft.) Flow Characteristics: **None**

Infiltration: **None** Pipe Seal Cond: **Unknown**

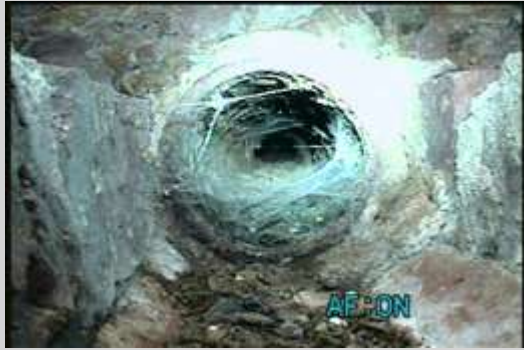
6 O'Clock Inflow

8 in. Circular Gravity Sewer  
Pipe In @ 6 O'Clock

Pipe Material: **Clay** ☐ Pipe Lined

Invert Depth: **5.50** (ft.) Flow Characteristics: **None**

Infiltration: **None**
